## SAMPLE INSPECTION SUMMARY

WITH REPRESENTATIVE PHOTOGRAPHS

| Sample property | Lakewood, Colorado |
| Company | FalconPoint Inspections LLC |

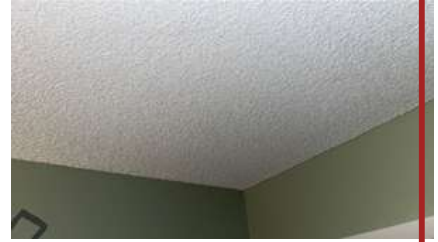
### Smoke detectors missing

**Location:** Interior - sleeping areas

**Observation:** At the time of the inspection, smoke detectors were not observed in one or more required or recommended locations. Missing alarms reduce the ability to provide early warning during a fire.

**Recommendation:** Install listed smoke alarms in the appropriate locations and test all alarms after installation. A qualified contractor should correct the condition where wiring or mounting work is needed.

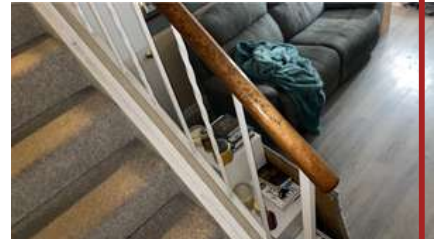
### Loose handrail

**Location:** Interior stairs

**Observation:** At the time of the inspection, the handrail was loose. A loose handrail may not provide dependable support and could contribute to a fall.

**Recommendation:** Secure or repair the handrail using appropriate fasteners and backing. Recommend repair by a qualified contractor.

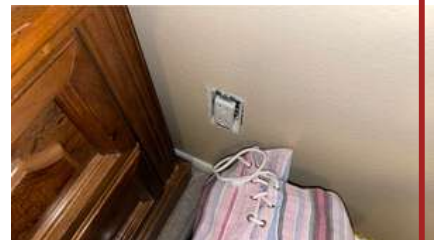
### Missing electrical cover

**Location:** Interior receptacle or junction box

**Observation:** At the time of the inspection, a cover plate was missing, leaving the electrical box or its interior accessible. Contact with energized components may result in shock.

**Recommendation:** Install the correct cover and have exposed or damaged wiring evaluated as needed by a qualified electrical contractor.

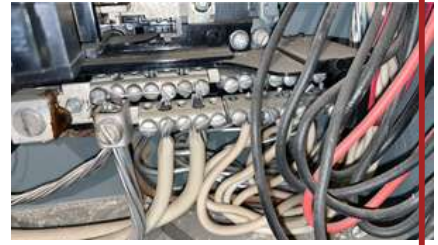
### Aluminum branch-circuit wiring observed

**Location:** Electrical service panel

**Observation:** At the time of the inspection, aluminum branch-circuit conductors were visible in the electrical panel. Connections involving this wiring type can be sensitive to improper devices, workmanship, oxidation, or loosening.

**Recommendation:** Have a qualified electrical contractor evaluate the accessible electrical system and complete corrections considered necessary.

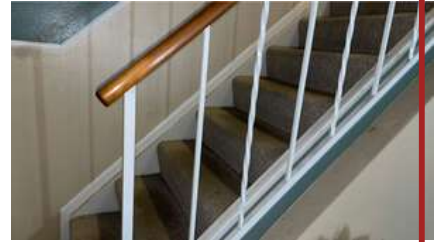
### Excessive baluster spacing

**Location:** Interior stairs

**Observation:** At the time of the inspection, openings between representative stair balusters appeared wider than current safety guidance. Larger openings can present a fall or entrapment concern, particularly for children.

**Recommendation:** Have a qualified contractor evaluate and modify the guard assembly as appropriate.

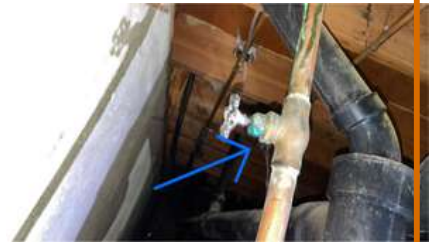
## Main water shutoff leaking or corroded

**Location:** Crawlspace

**Observation:** At the time of the inspection, the main water shutoff showed corrosion and visible leakage. Continued leakage can damage surrounding materials and the valve may not operate reliably when needed.

**Recommendation:** Have a qualified plumbing contractor repair or replace the affected valve and verify proper operation.

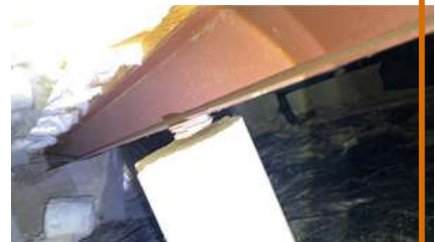
## Support post installation was improper

**Location:** Crawlspace

**Observation:** At the time of the inspection, a support post appeared improperly installed or inadequately secured. The visible installation may not provide dependable load transfer.

**Recommendation:** Have a qualified structural contractor or engineer evaluate the support and specify any necessary correction.

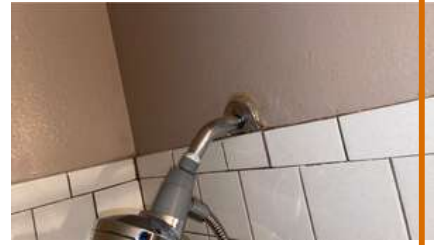
### Shower-arm penetration improperly finished

**Location:** Upper-level bathroom

**Observation:** At the time of the inspection, the wall finish and trim around the shower-arm penetration were improperly installed. The condition may permit moisture entry behind the finish or place unnecessary stress on the plumbing connection.

**Recommendation:** Have a qualified plumbing or tile contractor expose the trim as needed, evaluate the connection, and finish and seal the penetration properly.

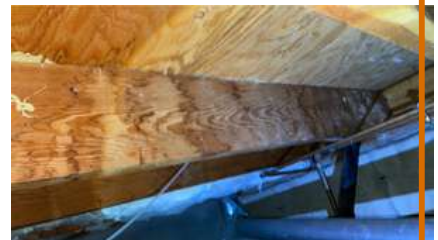
### Crawlspace moisture staining

**Location:** Crawlspace subfloor

**Observation:** At the time of the inspection, moisture staining was visible on portions of the subfloor. The material was not visibly wet at the time of the inspection, but the source and repair history could not be confirmed.

**Recommendation:** Identify and correct the moisture source if it remains active. Have damaged materials evaluated and repaired by a qualified contractor.

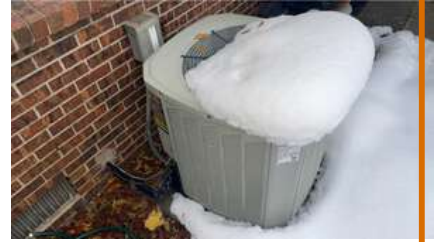
#### Air-conditioning equipment beyond typical service age

**Location:** Exterior cooling equipment

**Observation:** At the time of the inspection, the air-conditioning equipment appeared to be at or beyond the commonly expected service-life range. Age alone does not determine failure, but reliability and efficiency may be reduced. Operation was limited by outdoor conditions.

**Recommendation:** Obtain service records and have the system evaluated by a qualified HVAC contractor. Budget for eventual replacement.

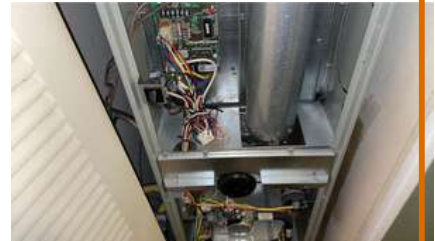
#### Furnace service recommended

**Location:** Heating equipment

**Observation:** At the time of the inspection, dust, debris, and general condition indicated that routine professional service may be due. The inspection did not include dismantling or internal heat-exchanger analysis.

**Recommendation:** Have a qualified HVAC contractor clean, service, and evaluate the furnace before continued seasonal use.

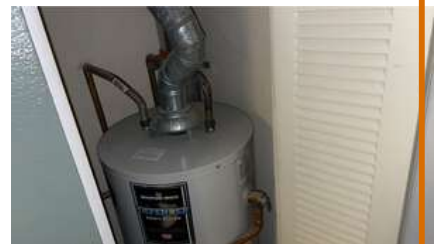
#### Water heater beyond typical service age

**Location:** Water-heating equipment

**Observation:** At the time of the inspection, the water heater appeared to be at or beyond the commonly expected service-life range. Older tanks have an increased likelihood of leakage or component failure.

**Recommendation:** Have the unit serviced or evaluated as appropriate and budget for replacement. Install leakage protection where practical. All repairs, corrections, or further evaluations should be completed by a qualified contractor.

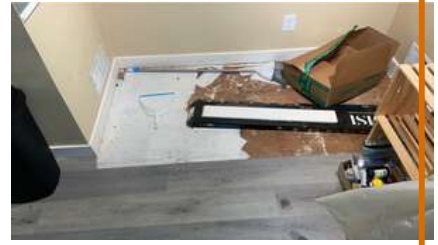
**[R] REPAIR RECOMMENDED****Damaged or missing flooring**

**Location:** Interior floor

**Observation:** At the time of the inspection, flooring was missing or damaged in a representative area, leaving the substrate exposed and creating an unfinished walking surface.

**Recommendation:** Have a qualified contractor repair or replace the affected flooring components and evaluate the substrate for concealed damage when exposed.

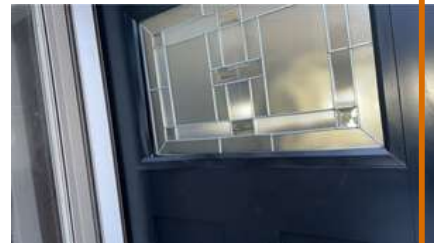
**[R] REPAIR RECOMMENDED****Damaged exterior door**

**Location:** Exterior entry

**Observation:** At the time of the inspection, the exterior door displayed visible damage or deterioration that may affect operation, weather resistance, or security.

**Recommendation:** Have a qualified door contractor evaluate and repair or replace the affected components.

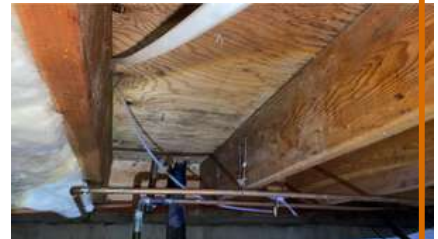
**[R] REPAIR RECOMMENDED****Crawlspace insulation displaced**

**Location:** Crawlspace

**Observation:** At the time of the inspection, insulation was missing or had fallen from portions of the floor framing. Displaced insulation reduces thermal performance and may conceal moisture or pest activity.

**Recommendation:** Have a qualified contractor evaluate and reinstall the insulation.

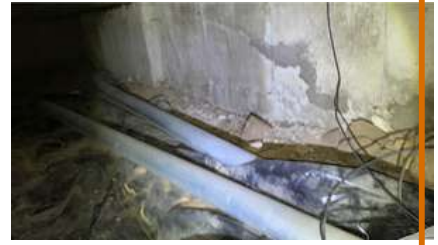
**[R] REPAIR RECOMMENDED****Crawlspace soil cover incomplete**

**Location:** Crawlspace floor

**Observation:** At the time of the inspection, the plastic soil cover was not continuous or sealed at perimeter seams and wall transitions. Open soil can contribute moisture vapor to the crawlspace.

**Recommendation:** Have a qualified contractor repair and secure the ground cover, including appropriate overlaps and perimeter detailing.

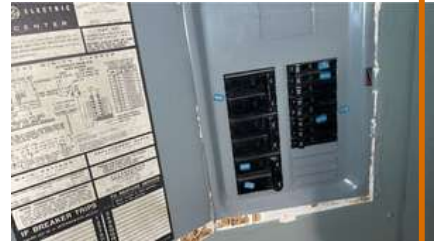
**[R] REPAIR RECOMMENDED****Electrical panel identification incomplete**

**Location:** Electrical panel

**Observation:** At the time of the inspection, panel labeling was incomplete or unclear. Inadequate identification can delay safe circuit isolation during service or an emergency.

**Recommendation:** Have a qualified electrical contractor accurately identify circuits and restore required equipment information where feasible.

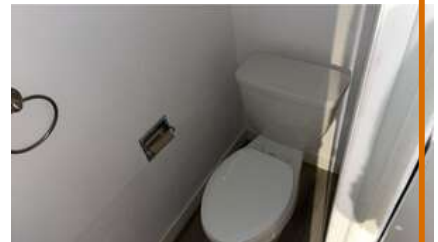
**[R] REPAIR RECOMMENDED****Toilet did not operate**

**Location:** Main-floor bathroom

**Observation:** At the time of the inspection, the toilet did not operate as intended. The cause was not determined during this visual inspection.

**Recommendation:** Have a qualified plumbing contractor evaluate and repair the toilet, then test it for proper operation and leakage.

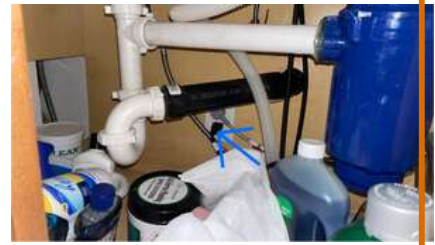
**[R] REPAIR RECOMMENDED****Sink drain improperly sloped**

**Location:** Kitchen sink

**Observation:** At the time of the inspection, a section of the sink drain appeared to slope away from the intended drain direction. Improper slope can retain water and debris and contribute to slow drainage or blockage.

**Recommendation:** Have a qualified plumbing contractor correct the drain configuration and verify that connections remain leak-free.

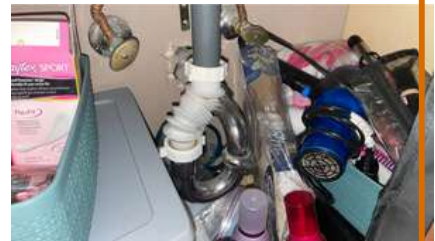
**[R] REPAIR RECOMMENDED****Flexible corrugated drain installed**

**Location:** Bathroom sink

**Observation:** At the time of the inspection, a flexible corrugated drain component was installed below the sink. Corrugations can collect debris and are more difficult to clean than smooth-wall drainage fittings.

**Recommendation:** Replace the flexible section with properly configured smooth-wall drainage components by a qualified plumbing contractor.

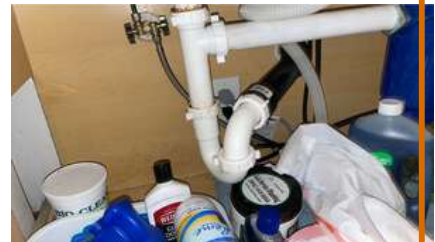
**[R] REPAIR RECOMMENDED****Mixed or irregular kitchen drain materials**

**Location:** Kitchen sink

**Observation:** At the time of the inspection, the visible drain assembly contained dissimilar or irregularly configured materials. No active leakage was visible during the inspection, but the installation may be difficult to service or keep reliably sealed.

**Recommendation:** Have a qualified plumbing contractor evaluate and correct the drain assembly as needed.

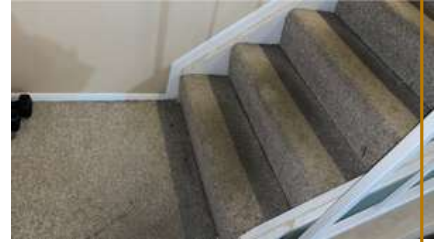
#### Carpet staining and wear

**Location:** Interior floor coverings

**Observation:** At the time of the inspection, carpeting showed visible staining or wear. The inspection did not determine whether all staining can be removed or whether concealed damage is present below the carpet.

**Recommendation:** Have the carpeting cleaned and evaluated by a qualified contractor. Replace the carpeting or repair the substrate as recommended by that contractor.

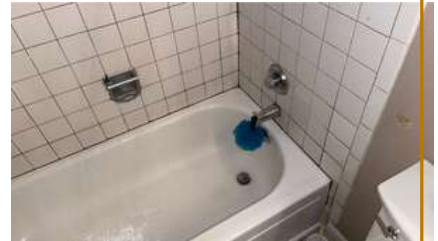
#### Tub and shower grout deteriorated

**Location:** Bathroom tub/shower

**Observation:** At the time of the inspection, grout or sealant was deteriorated at representative tub or shower joints. Failed joints can allow water to reach concealed wall or floor materials.

**Recommendation:** Have a qualified contractor evaluate and repair the deteriorated grout or sealant as necessary.

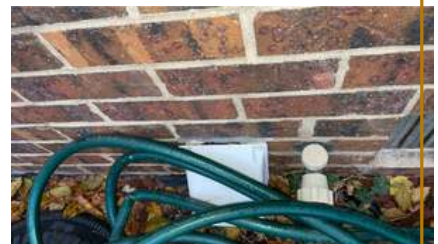
#### Exterior dryer vent opening not sealed

**Location:** Exterior wall - dryer exhaust vent

**Observation:** At the time of inspection, gaps were observed around the dryer vent where it passes through the exterior wall. These gaps may allow moisture and pests to enter.

**Recommendation:** Recommend a qualified contractor evaluate and properly seal around the vent penetration while keeping the exhaust opening and damper unobstructed.

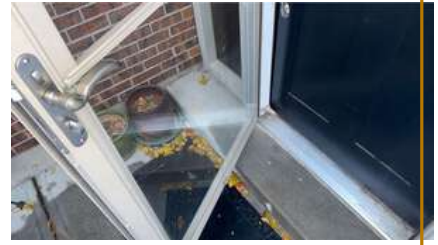
**[M] MAINTENANCE / MONITOR****Exterior sealant maintenance needed**

**Location:** Exterior penetrations and trim

**Observation:** At the time of the inspection, sealant was missing or deteriorated at representative exterior joints or penetrations. Open joints can admit water and contribute to deterioration.

**Recommendation:** Remove failed material and apply compatible exterior-grade sealant at affected areas. All repairs, corrections, or further evaluations should be completed by a qualified contractor.

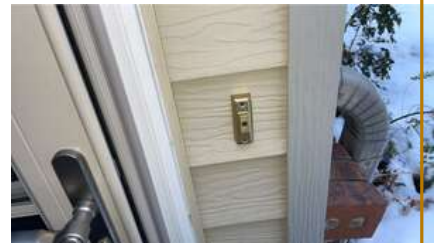
**[M] MAINTENANCE / MONITOR****Doorbell button damaged**

**Location:** Exterior entry

**Observation:** At the time of the inspection, the doorbell button was damaged but operated when tested. Continued exposure may lead to intermittent operation.

**Recommendation:** Repair or replace the button as needed. All repairs, corrections, or further evaluations should be completed by a qualified contractor.

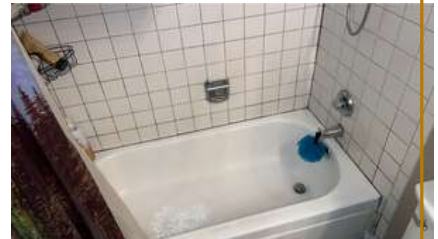
**[M] MAINTENANCE / MONITOR****Tub stopper missing or inoperable**

**Location:** Bathroom tub

**Observation:** At the time of the inspection, the tub stopper was missing or did not retain water. Because the tub could not be filled normally, evaluation of the overflow and full drainage cycle was limited.

**Recommendation:** Repair or replace the stopper and test the filled tub, overflow, and drainage connections for leakage. All repairs, corrections, or further evaluations should be completed by a qualified contractor.

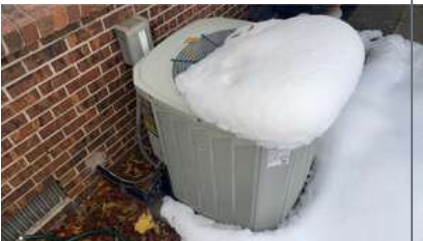
Cooling system not operated

Location: Cooling

**Observation:** At the time of the inspection, the air-conditioning system was not operated because outdoor temperature was below the company operating threshold. Operation under unsuitable conditions may damage equipment.

**Recommendation:** Have a qualified HVAC contractor evaluate cooling operation when weather conditions permit.
